Test Report No. 7191039503-MEC13-01-DL
dated 8 Feb 2013

SUBJECT: Durability test of shower hinge.

METHOD OF TEST: Adopted from BS EN 1935: 2002
Building hardware – single axis hinges – Requirements and test methods
Clause 5.4 (Requirements) and Clause 7.5 (test method)

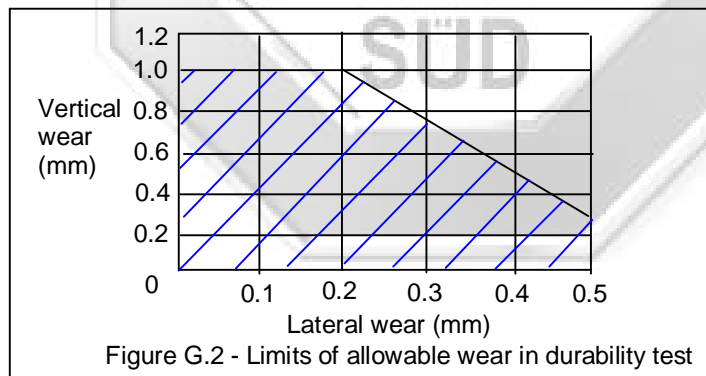
Initial at 20 cycles (mm)	After 50,000 cycles (mm)	Wear measurement (mm)	Results	BS EN 1935: 2002 Clause 5.4 (Requirements)
Horizontal gap	251.37	251.56	0.19	Passed up to 50,000 cycles.	The amounts of lateral and vertical wear of the hinge tested measured as displacements of the datum surfaces shall be within the shaded area as shown in Figure G.2
Vertical gap	280.44	281.36	0.92

Remarks: 1) Door was able to perform self-closing function up to 50,000 cycles.
2) The horizontal & vertical wear maintain within specification up to 50,000 cycles.
3) The shower hinge passed the endurance test up to 50,000 cycles.

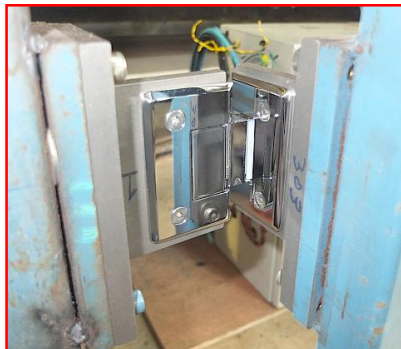
Figure 5: Lower hinge under test
(open position)

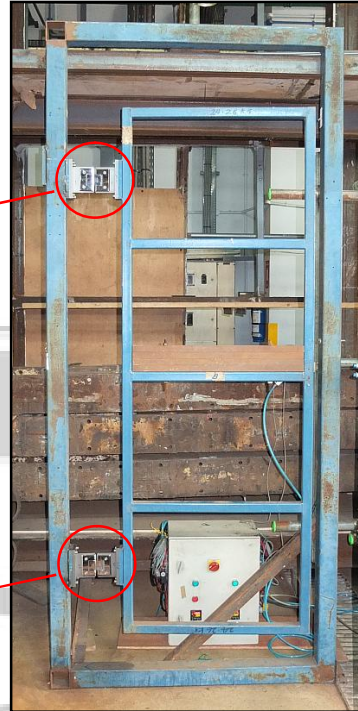
Figure 4: Door in close position

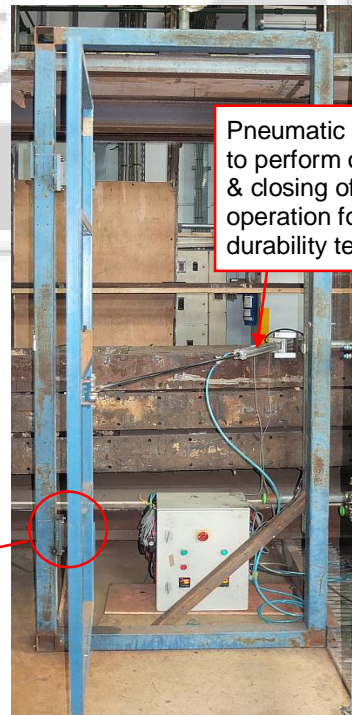
Figure 6: Door in open position (90°)
