Test Report No. 7191039503-MEC13-03-DL
dated 8 Feb 2013

SUBJECT: Durability test of shower hinge.

METHOD OF TEST: Adopted from BS EN 1935: 2002
Building hardware – single axis hinges – Requirements and test methods
Clause 5.4 (Requirements) and Clause 7.5 (test method)

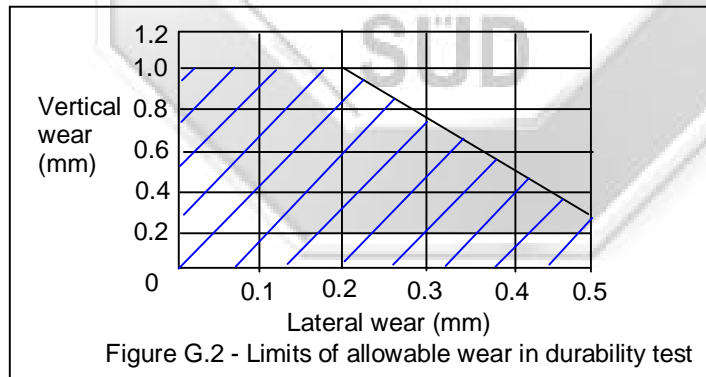
Initial at 20 cycles (mm)	After 60,000 cycles (mm)	Wear measurement (mm)	Results	BS EN 1935: 2002 Clause 5.4 (Requirements)
Horizontal gap	188.48	188.66	0.18	Passed up to 60,000 cycles.	The amounts of lateral and vertical wear of the hinge tested measured as displacements of the datum surfaces shall be within the shaded area as shown in Figure G.2
Vertical gap	145.02	145.25	0.23

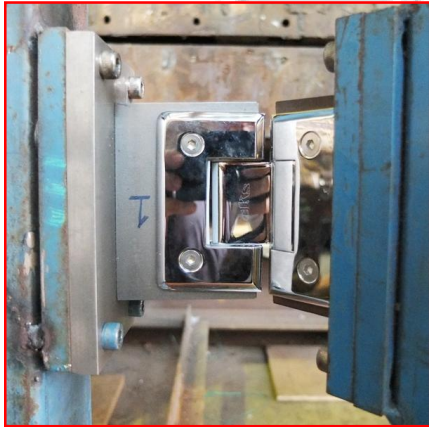
Figure 3: Lower hinge under test (close position)

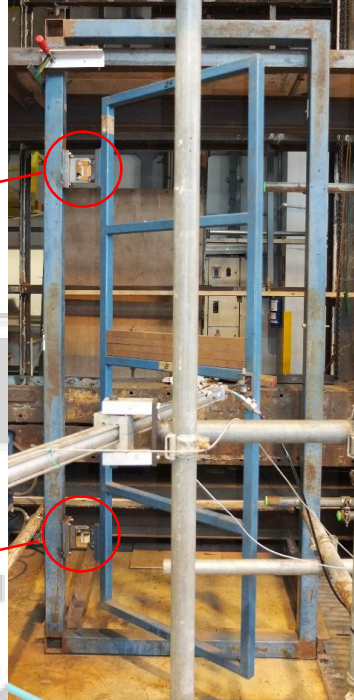
Figure 4: Door in close position

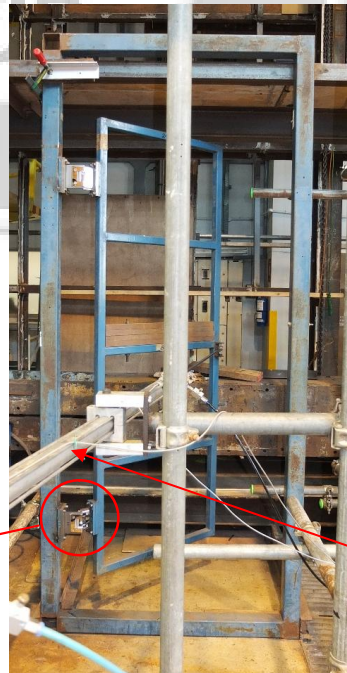
Figure 6: Door in open position (90°)

Pneumatic actuator to perform opening & closing of door operation for the durability test.

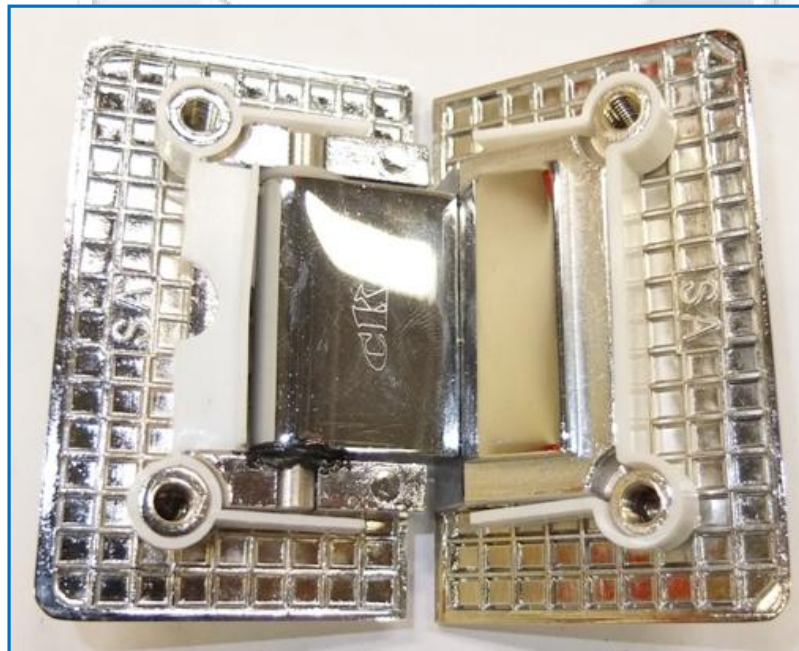
Figure 8: Lower hinge after 60,000 cycles of durability test

Remarks: 1) Door was able to perform self-closing function up to 60,000 cycles.
 2) The horizontal & vertical wear maintain within specification up to 60,000 cycles.
 3) The shower hinge passed the endurance test up to 60,000 cycles.
